WATER RESOURCES INVESTIGATION

*MILLER RUN and AYERS BROOK
VERMONT
CONNECTICUT RIVER BASIN*

SITUATION REPORT

SEPTEMBER 1976

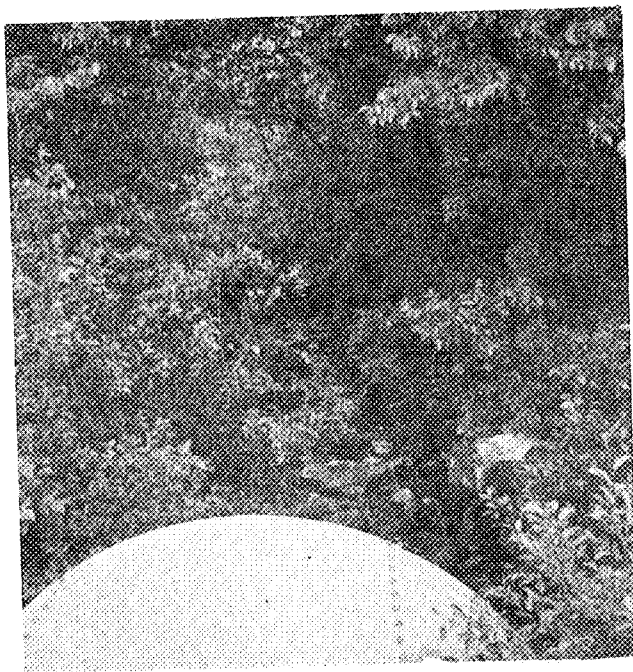
Fig. I - 1

Zone I begins in the town of Sheffield where Nation Brook and Trout Brook join to form Miller Run. Nation Brook (Fig. I-1) crosses under State Route 122 through a corrugated metal arch pipe approximately six feet high. No problems exist in this area. The channel is lined with rock, six to twelve inches in diameter, and the culvert and bridge openings (Fig. I-2 to I-4) appear to be more than adequate.

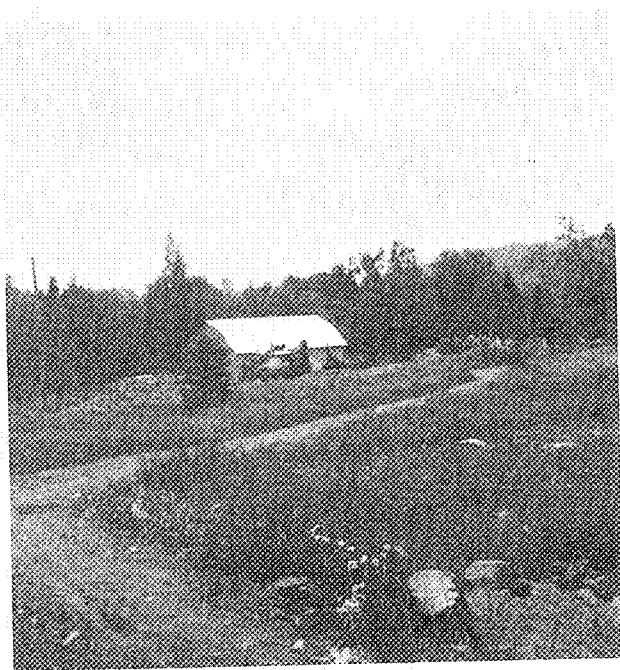
Fig. I - 9

From here the brook parallels Route 122 for about a mile and is crossed by a footbridge (Fig. I-5) and a wooden bridge. The footbridge is located in a wooded area spotted with an occasional house or barn. Fig. I-6 and I-7 taken looking upstream and downstream from the wooden bridge (Fig. I-8) show a rock lined channel bordered by overhanging trees and brush. The bridge provides access to the sawmill in Fig. I-9.

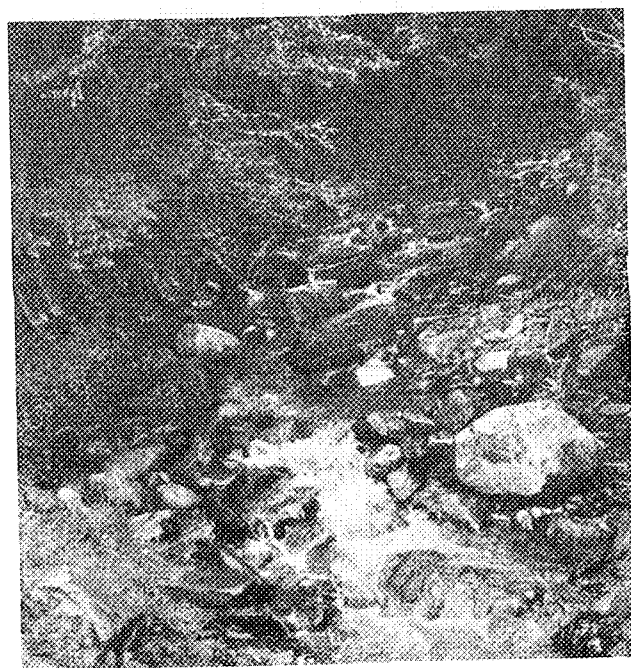
Fig. I - 20

From here the stream continues to flow through a heavily wooded area approximately 300 feet from Route 122. Square Brook (Fig. I-20) flows rapidly from Ferguson Hill under Route 122, then down into the heavily wooded area (Fig. I-21) where it then joins Miller Run. A

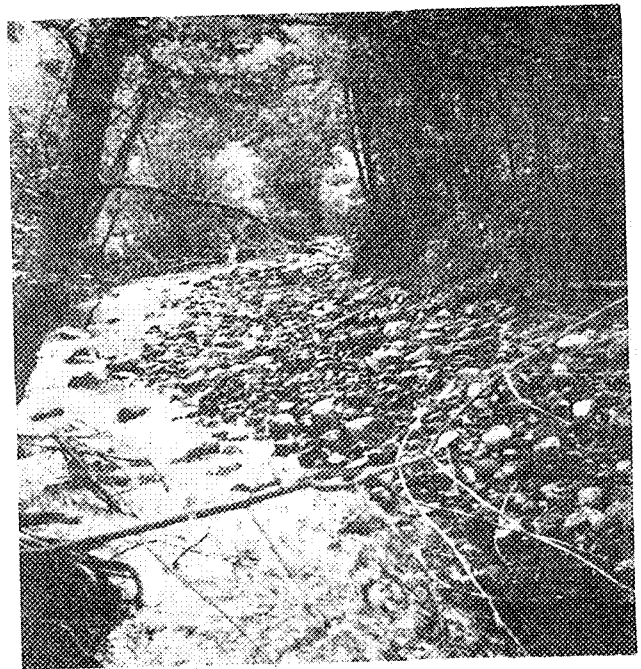
Fig. I - 22

rather larger rock deposit (Fig. I-22) is located here. During the spring the ice flow might collect in this area, damaging the stream and causing flooding of adjacent fields and wooded areas. Flood damage as a result of such an occurrence would be minor since the deposit is in an undeveloped area about 1,500 feet from Route 122. Other smaller rock deposits frequent the stretch of Miller Run between Square Brook and the old white church in Sheffield. Access to these areas is also difficult.

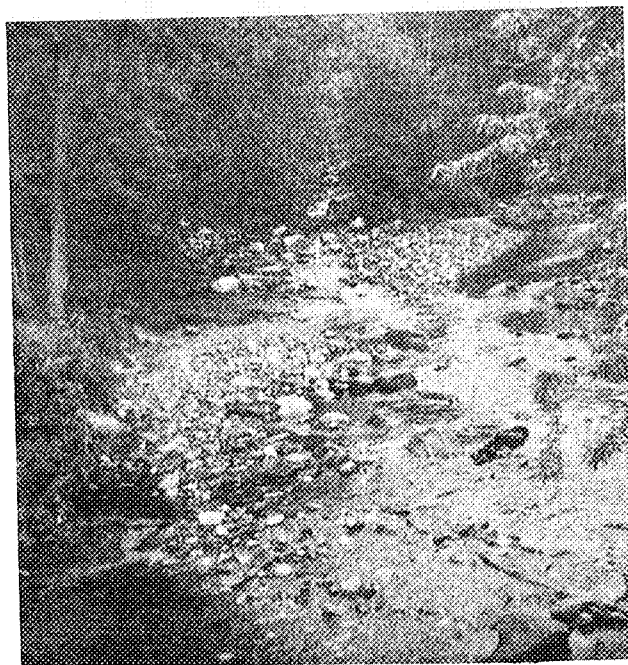
Fig. I - 27

Miller Run, continues southerly for about 500 feet where it is then joined by Tributary D. Looking upstream from a privately owned wooden bridge, rather large gravel deposits (Fig. I-27) mark the confluence. Should ice flows jam in this area several homes in Sheffield center may experience some flooding. This area is easily accessible and is a potential harvest area. Looking downstream, rock outcrops and several small gravel deposits are visible (Fig. I-28). Access to these deposits would be difficult but since they do not present a flood hazard, it is not necessary that they be removed.

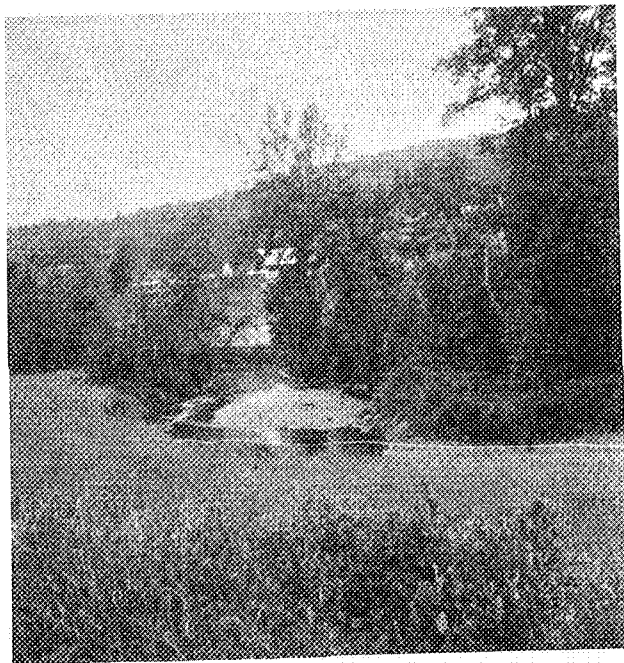
Fig. II - 17

From the Sheffield-Wheelock town line to the end of Zone II, several small sand and gravel deposits are located on the inside of all bends in Miller Run (Fig. II-17). Rock outcrops (Fig. II-18 to II-20) are found in this stretch with fallen trees and debris sometimes found along the banks. After its descent down the steep ledge fall shown in Fig. II-19, the gradient flattens and the stream crosses Route 122 twice through Wheelock then follows alongside the highway. No problems were observed in this area.

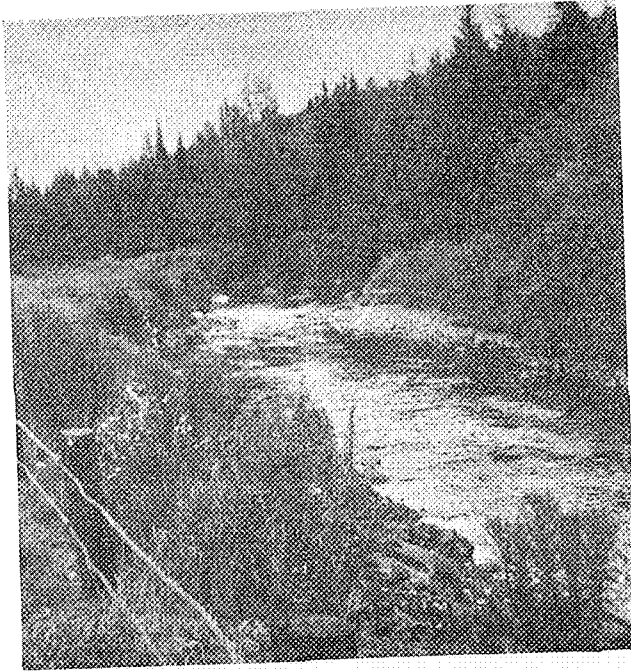
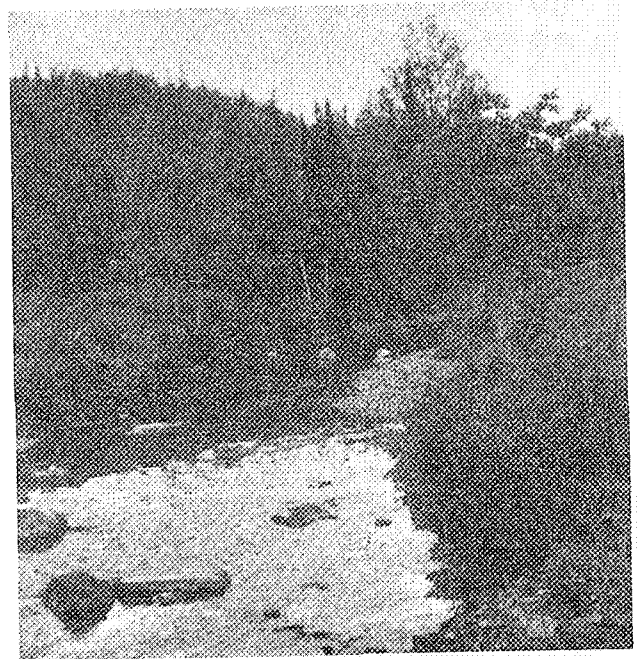
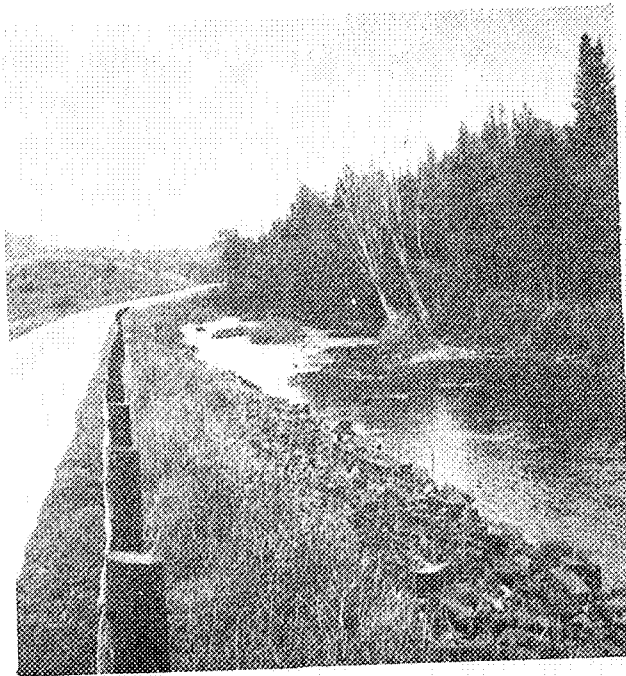
Zone III begins where Mathewson Brook joins the main stem of Miller Run. Throughout most of this zone Miller Run follows closely the course of Route 122. Small deposits such as those in Fig. III-1 to Fig. III-3 are found along this entire stretch of river. Although access to these areas is easy the small quantities at each location would not sufficiently offset the removal costs and since they do not present any flood threat they need not be removed. Fallen trees such as the one in Fig. III-4 are also found in this zone. During flood events they would present a major hydraulic restriction resulting in flooding of Route 122 and the surrounding area.

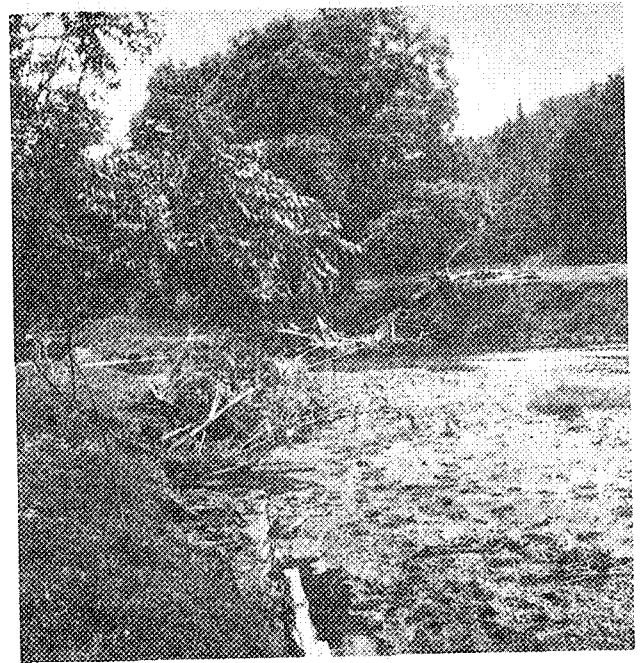
Fig. III - 6

Further downstream the stream flows adjacent to farmlands causing some minor bank erosion and depositing sand and gravel on the inside of most bends. One major erosion and sedimentation problem exists along this stretch and is shown in Fig. III-5 to III-7. Another is shown in Fig. III-8.

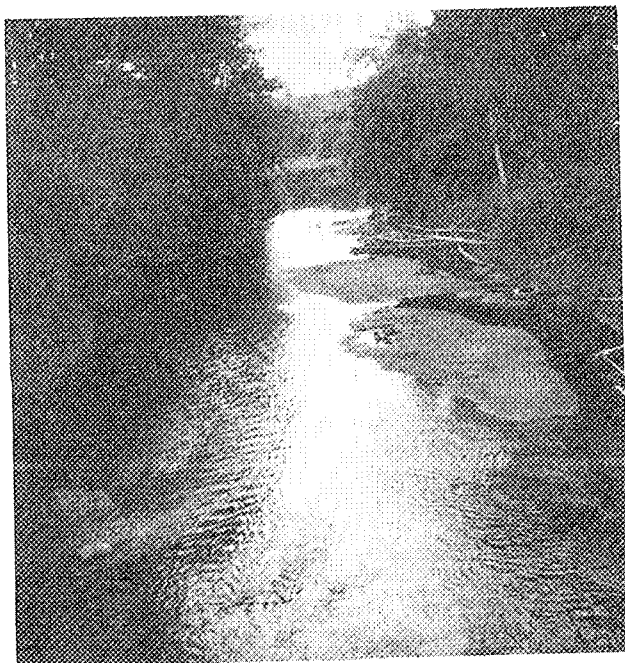
Fig. IV - 2

Zone IV begins where Tributary I joins Miller Run. About a half mile downstream the brook flows under a recently constructed bridge (Fig. IV-1) located on a back road to Lyndon Center. Downstream of the bridge sand and gravel deposits as well as dead trees and debris are located along the right bank (Fig. IV-2).

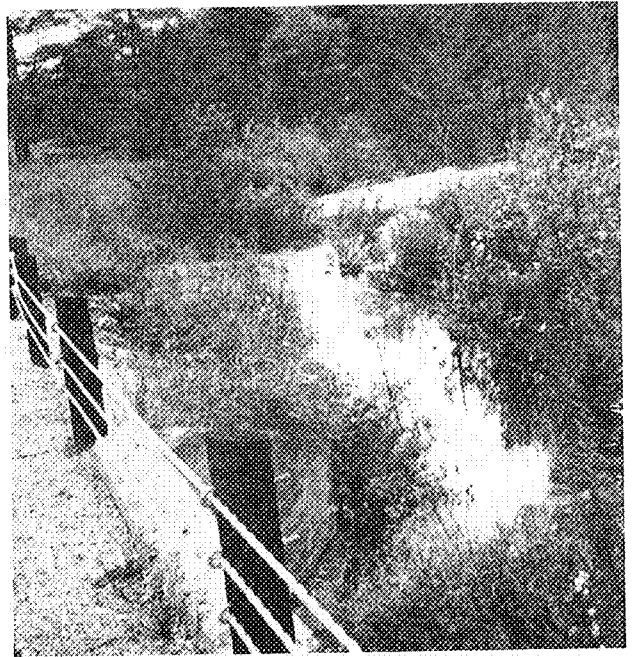
Fig. I - 10

Zone I of Ayers Brook begins in Brookfield Gulf and ends at its confluence with Open Meadow Brook. In the upper reaches of Zone I the brook is quite small, often hidden amongst the tall ferns and heavy brush. The brook follows closely the course of State Route 12 with the base of the roadway embankment forming one side of its channel (Fig. I-1 to I-8). During high flows, the gravel material along the shoulder of the road often washes away and frequent repair work is required by the State of Vermont (Fig. I-3, I-8, and I-15). The brook crosses Route 12 several times along the Allis State Forest Park. Two of these crossings are shown in Fig. I-9 and I-10.

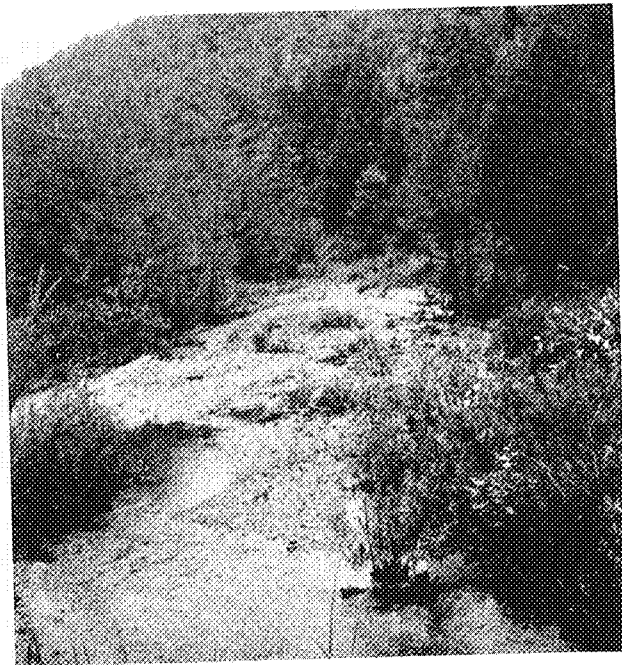
Fig. I - 11

Downstream of the culvert shown in Fig. I-10 the stream gradient flattens out, decreasing velocities and causing the deposition of a large quantity of gravel (Fig. I-11). The deposits have caused the brook to cut a new channel through the pine trees (Fig. I-12 and I-13). There is a large quantity of gravel available at this location and since access to the area is possible, a removal operation might be considered. Further downstream a wooden bridge (Fig. I-14) crosses the brook. Clearance beneath the deck is minimal causing branches and debris to get hung up on its upstream face. This bridge should be either removed or replaced.

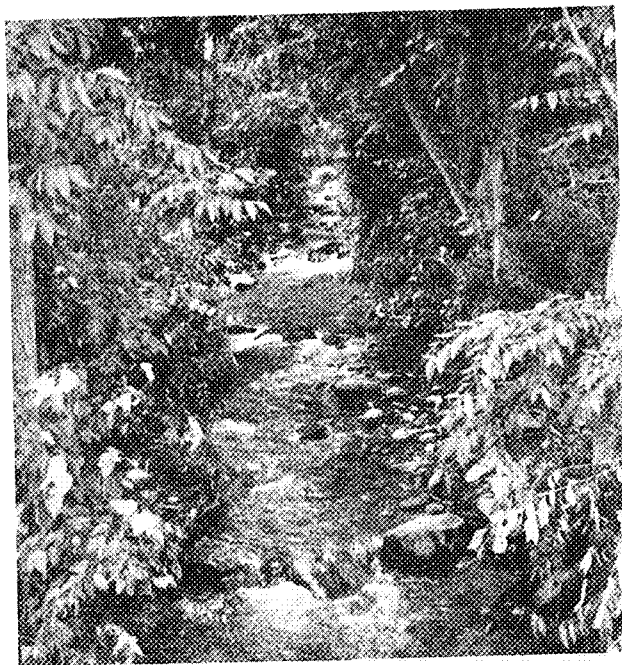
Fig. II - 5

Continuing downstream, the brook flows adjacent to several farms to East Braintree where it is then joined by Tributary D. Tributary D flows down from Pumpkin Rim (Fig. II-5), crosses under Route 12 (Fig. II-6), and continues some 300 feet to its confluence with Ayers Brook. In this final stretch, bank erosion has occurred (Fig. II-7 and II-8). An old footbridge (Fig. II-9) has been undermined and its remains are located in the stream.

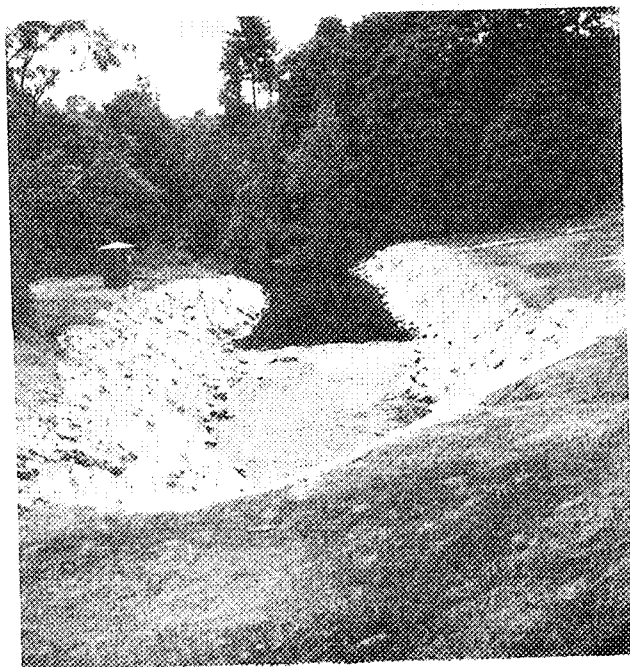
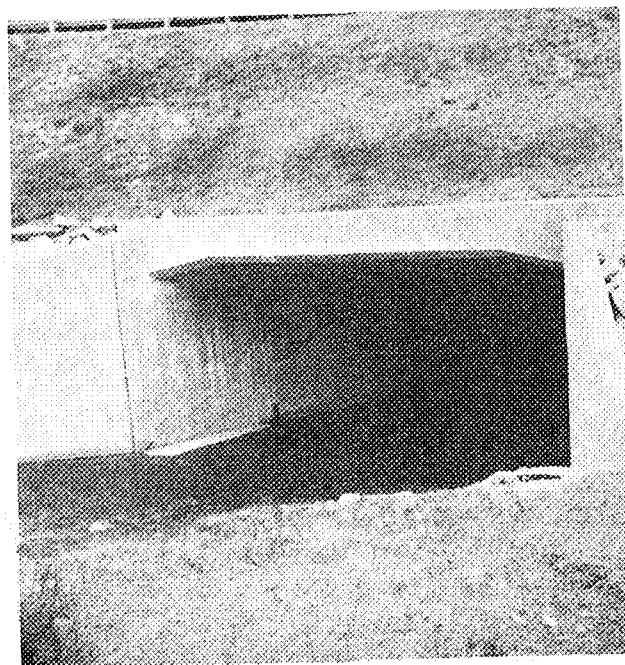
Zone IV begins at Tributary B and ends at the confluence of Ayers Brook and the Third Branch White River. Just as in the previous zones, small deposits are found on the inside of bends and erosion on the outside banks but they do not cause any serious flooding problems. The principal problem area, however, is located at the site of a defunct motel in the Town of Randolph. The motel once stood on a (40 x 50' high sandbank. Since 1962, the stream has cut into the bank approximately 100 feet. The motel was comprised of one four unit building and three single cabins. Over the years erosion has crept so far that the multi-unit had to be demolished in 1973 to prevent it from going over the bank. Now the cabins are endangered. The State of Vermont has constructed a new bridge at Route 12 (Fig. IV-3 and IV-4). The culvert (about 12'

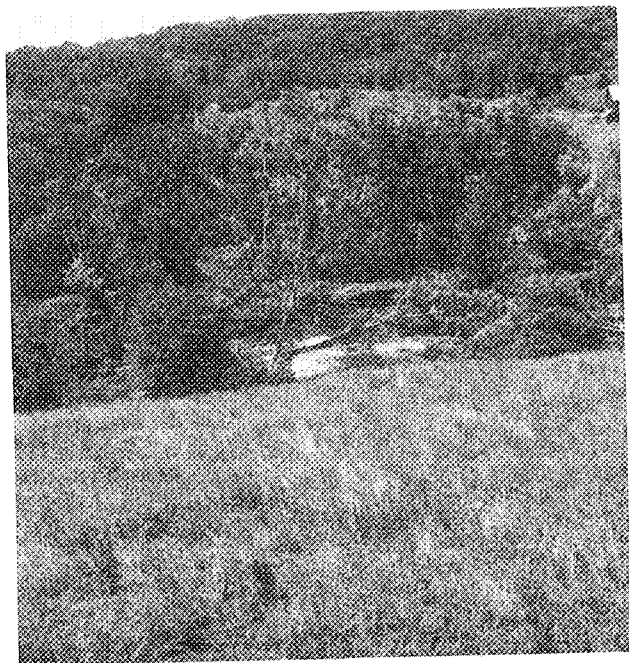
Fig. II - 13

course, falling trees, leaving sand and gravel deposits and eroding portions of the bank, (Fig. II-13 and II-14). No problems exist along Tributary F either upstream (Fig. II-16) or downstream (Fig. II-15) of the Route 12 bridge but just downstream of its confluence with Ayers Brook a significant change is underway. An old oxbow in the brook has been cut off (Fig. II-17 to II-19) leaving behind a sand and gravel deposit approximately 125 feet long x 100 feet wide x 2 feet deep in size. Trees have been undercut and banks eroded and the brook has begun to cut a new channel through the adjacent farmlands. This is an excellent harvesting location with access possible through the open field adjacent to the cemetery, located near Route 12. Flooding in this area is limited to the inundation of the neighboring fields. Smaller problem areas exist downstream of this point as is evidenced by the gravel bar downstream of the wooden bridge at Howard Hill Road, Fig. II-20. Just downstream of this bridge, Tributary G crosses Route 12 and joins Ayers Brook.
